1. REPORT NO. FHWA/CA/TL-79/17		2. GOVERNMENT ACCESSION NO.		3. RECIPIENT'S CATALOG NO.	
4. TITLE AND SUBTITLE ANALYSIS OF SHORT- AND LONG-TERM EFFECTS ON WATER QUALITY FOR SELECTED HIGHWAY PROJECTS				5. REPORT DATE August 1979

16. ABSTRACT <p>Research was undertaken at three highway construction projects in California to determine the influence on the water-quality environment. The projects were located on Interstate 5 in northern California at Dunsmuir, Route 395 in the high desert area north of Bishop, and on Interstate 5 in south Sacramento County. Each project involved contact with a live stream or river. Field data were assembled for the preconstruction and construction periods. In addition, the I-5 Dunsmuir and Route 395 Bishop projects included data collection for the postconstruction period.</p> <p>The data show that the water-quality study performed by the districts as part of the environmental assessment process is adequate to describe potential impacts in qualitative terms. Most construction-related impacts were not foreseen in the preconstruction environmental assessment. This report discusses each project study and conclusions.</p>

ANALYSIS OF SHORT- AND LONG-TERM

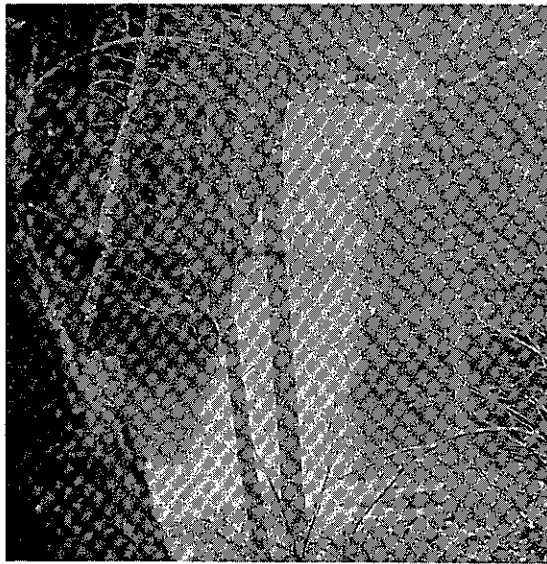
Photo 1  
Hedge Creek Falls During  
Winter High Flows

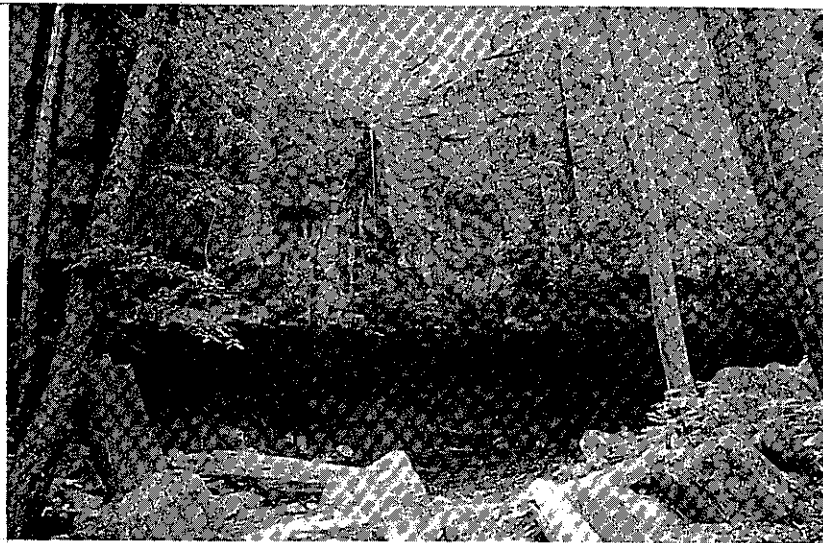
Photo 2  
Hedge Creek Falls During Drought

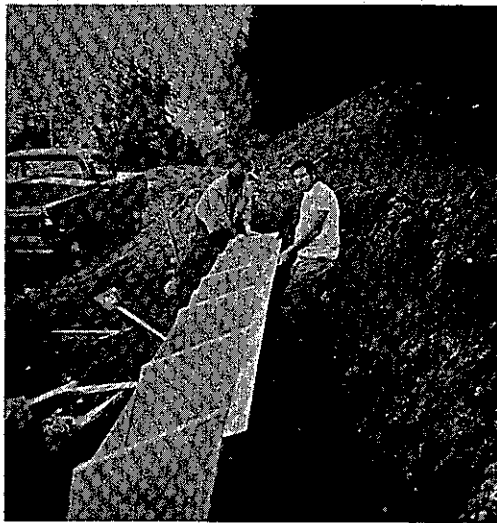
Photo 7  
Replacing the Sediment-  
Collection Troughs

Preconstruction slope erosion data on the existing large cut was monitored from October 12, 1973, through July 12, 1974. The two sediment-collection troughs were removed on July 12, 1974 due to reconstruction of the slope. After reconstruction of the slope, the troughs were replaced and sediment collection commenced again (Photos 7 and 8). Sediment collection for the period of construction was from June 12, 1975, through May 16, 1977. Due to the drought, minimal erosion occurred. The troughs were emptied only 4 times. The total accumulated sediment and precipitation for this period are shown in Table 11. For comparison, the sediment and precipitation data for the preconstruction period also are shown.

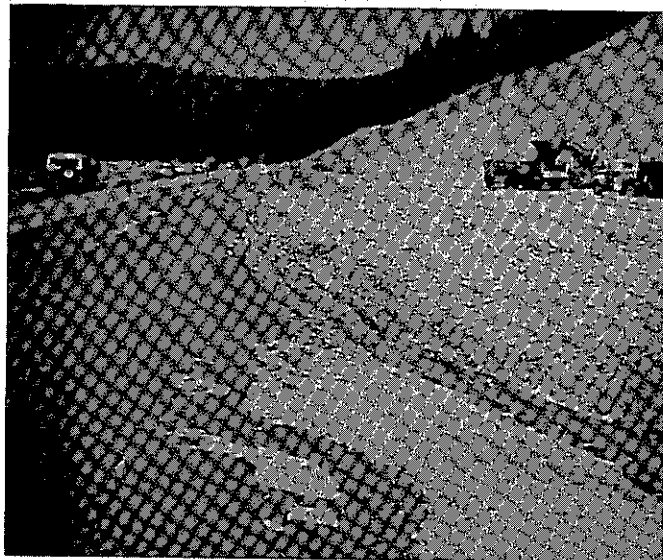
Photo 9

Wash Water From Daily Washing  
of the Existing Expressway  
During Construction

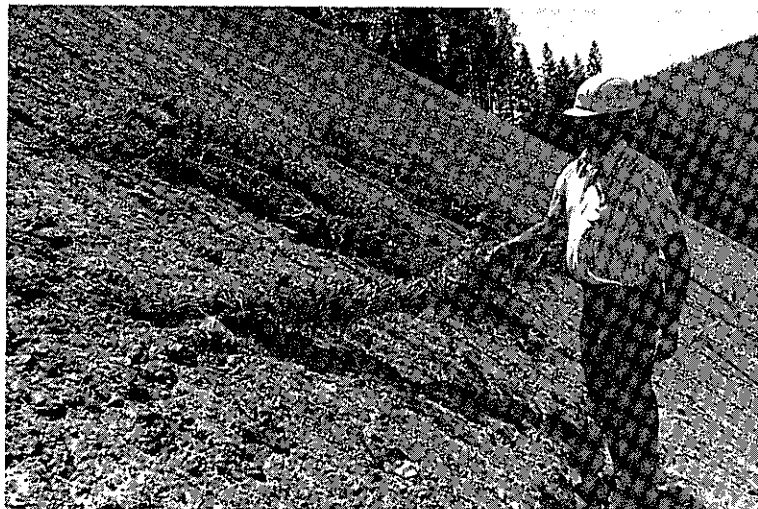
Photo 12  
Small Willow Wattling Bundles

time between cutting the willows and installing the bundles was 24 hours. These wattling bundles appeared to be superior to those from the landscape service in Redding. They were larger bundles and tied much better. The bundles from Redding had cost the contractor \$2.21 per bundle delivered to the jobsite. The bundles from Mount Shasta cost \$1.00 per bundle.

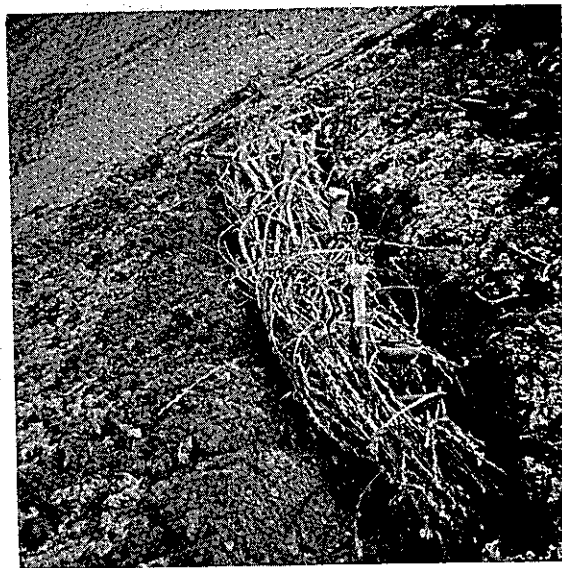
Photo 17  
Willow Wattling Bundle in Trench  
Prior to Backfilling (March 1976)

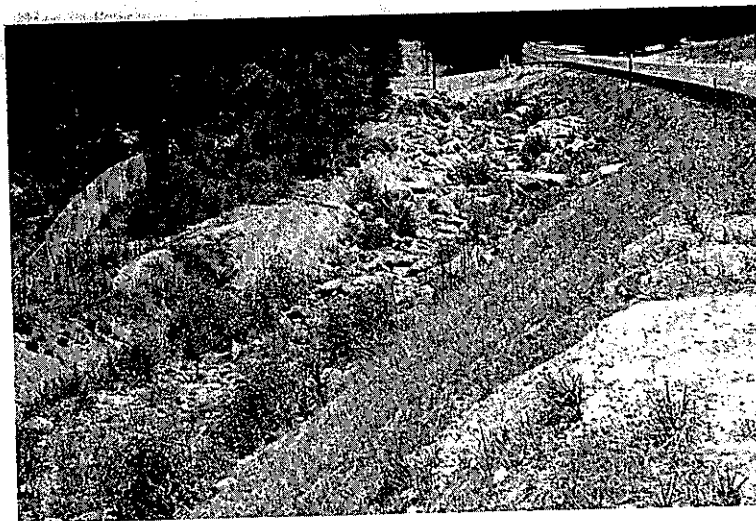
Photo 26  
Willow and Native Alder Growth (June 1977)

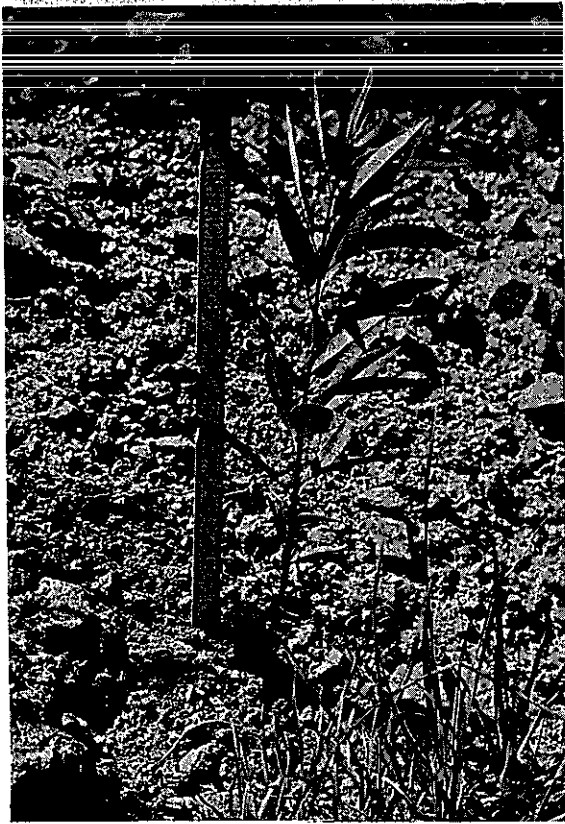
Photo 34

Willow Cutting (June 1977)  
Planted October 1976

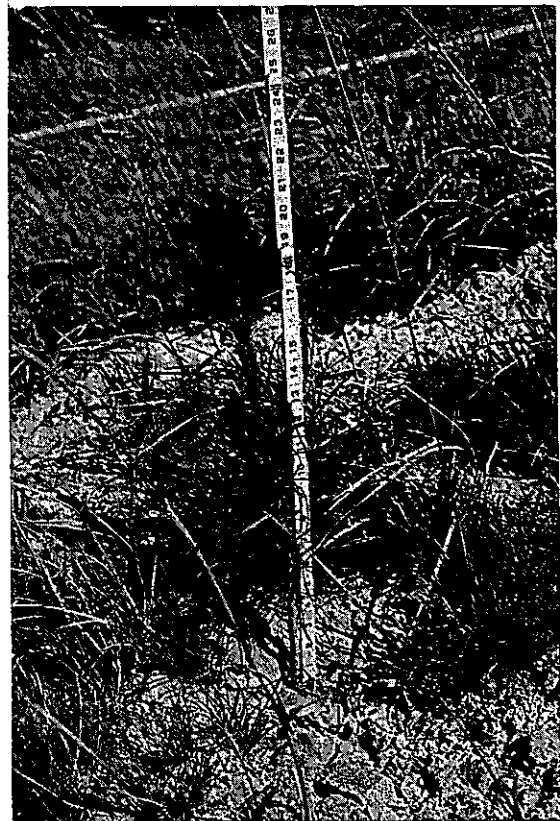
Photo 35

Ponderosa Pine (June 1977)  
Planted October 1976

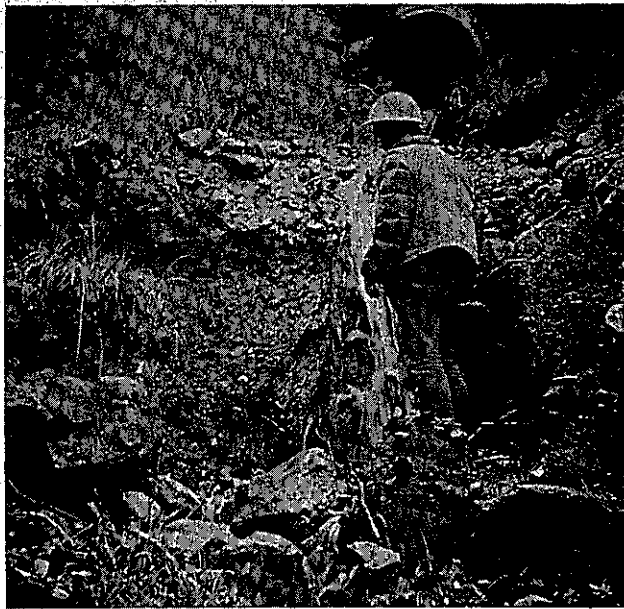
Photo 40

April 14, 1978  
 Scour Hole Below Culvert 7.  
 The Hole was 6 Feet Deep and  
 10 Feet Wide at Some Locations

Scouring below Culverts 6, 7, 8 and 9 was evident. A tremendous volume of material was scoured from around these culvert outlets. Erosion of Culverts 6, 7, 8 and 9 resulted in 8 cy, 34 cy, 22 cy and 2 cy, respectively (Photos 39 through 41). These figures represent the scour in the vicinity of the culvert outlets. Erosion of the area from the culvert outlet to the creek was evident, but was not measured.

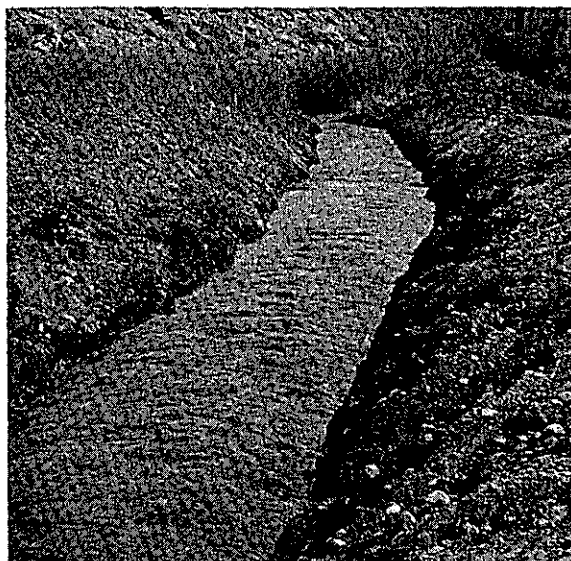
Photo 43 shows Rock Creek running clear, and turbidity tests taken at this time (2 days after diversion) indicated that the water flowing out of the temporary channel was as clear as that flowing in (about 2 to 3 N.T.U.).

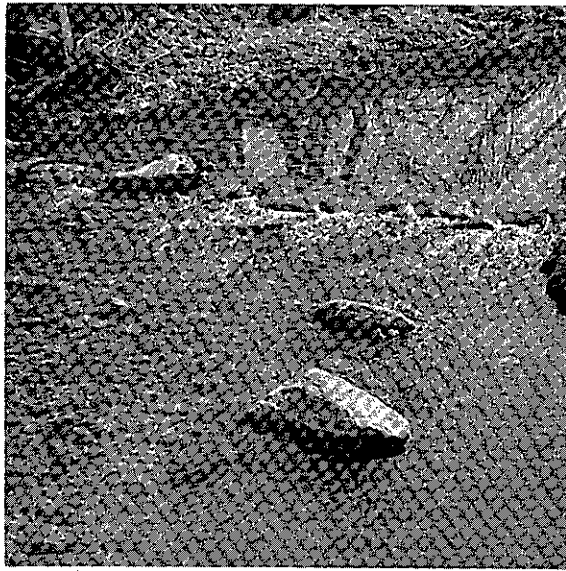
Photo 48

Sandbag check dam was used to slow velocity and reduce sediments from spring water flowing from natural channel of Pine Creek after main flow had been diverted (Photo 48).

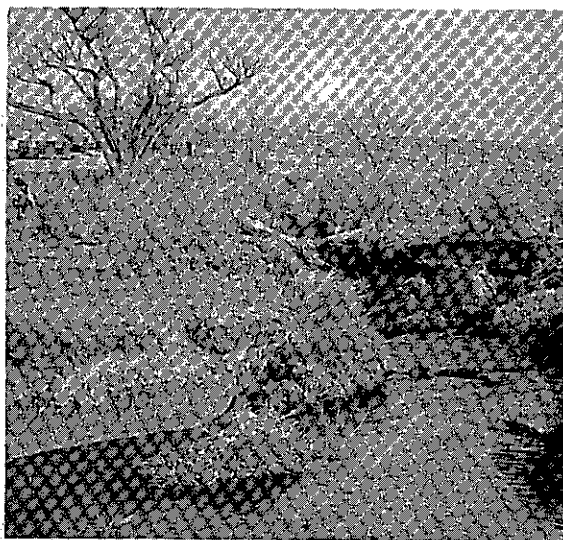
Photo 49 is a typical view of flowing streams on this project (Mill Creek). Mill Creek is one of four live streams which cross the highway alignment. This picture was taken before any work was done. Note the vertical banks and material which has fallen into stream.

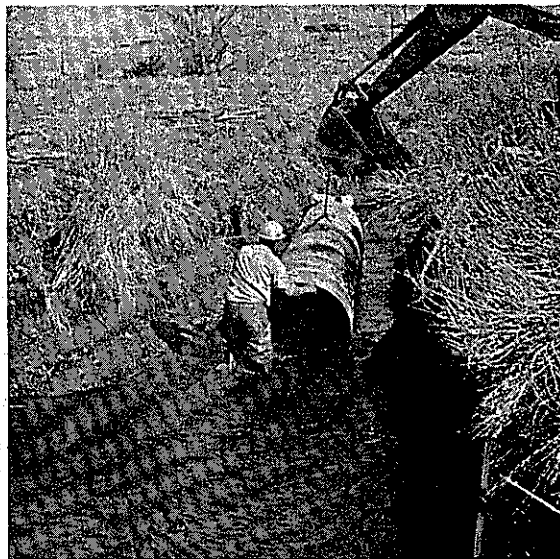
Photo 51 shows the placement of a pipe for temporary crossing in Horton Creek.

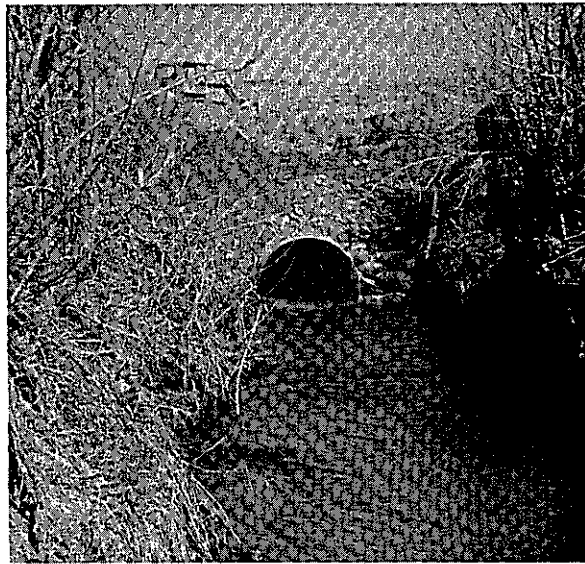
Photo 54 shows completed temporary equipment crossing after backfill has been placed.

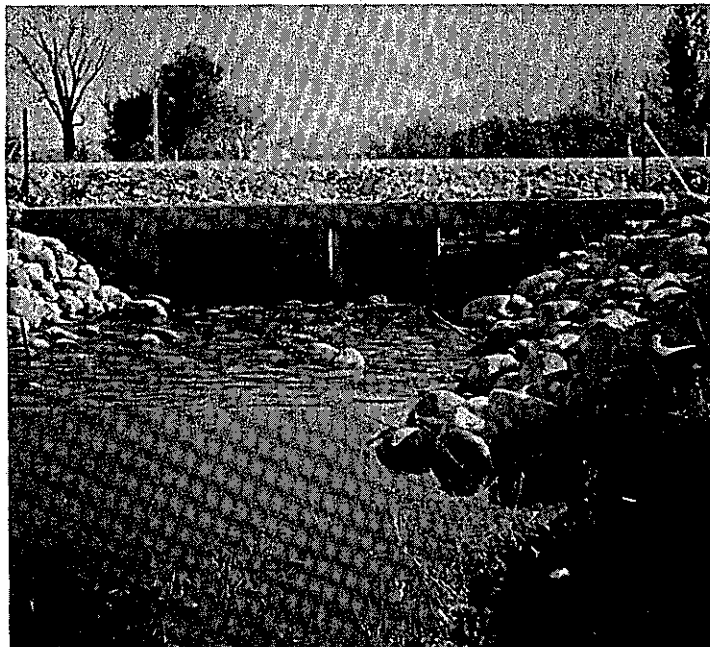
After the temporary channel diversions were completed, work proceeded on the permanent channel crossings. Photo 55 shows the completed structure crossing of Rock Creek near the highway connection to the old highway which is now a county road.

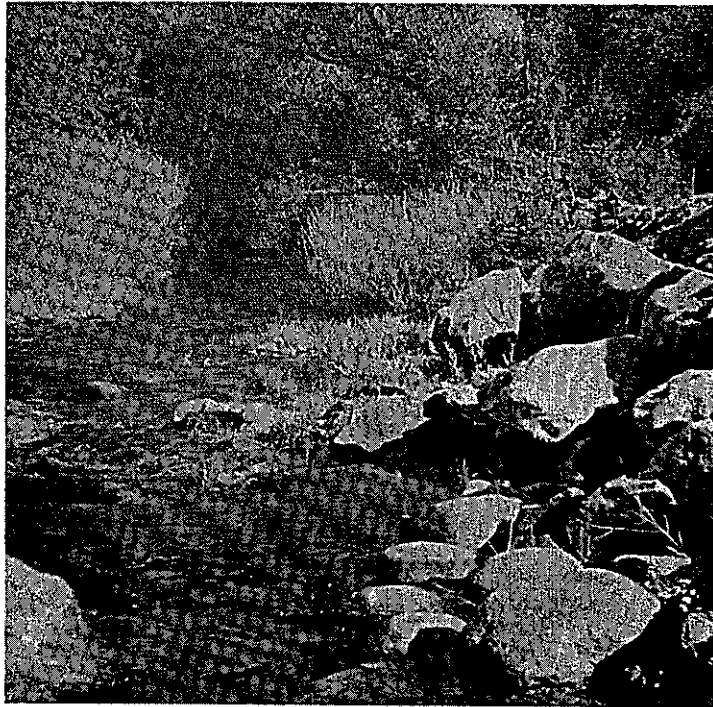
Looking downstream on Rock Creek from highway 395, Photo 57 shows the reconstructed channel blending in with the natural channel,

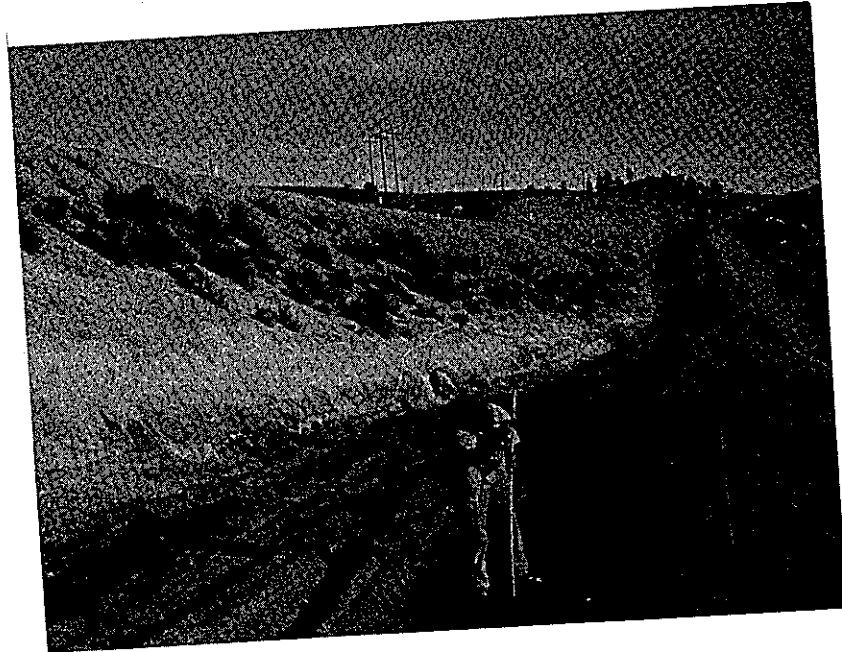
Photo 64  
Preparing Bench for Willow Cuttings  
November 1976

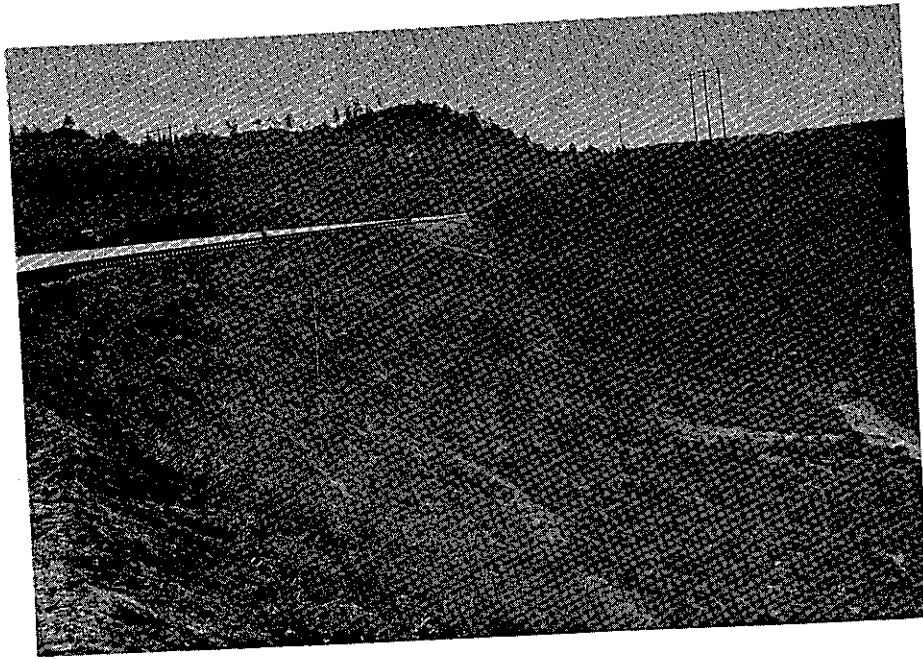
Photo 66

Large Fill Slope Showing Revegetation  
from Brush Layering & Duff Spreading.  
Facing in Direction of Southbound  
Traffic. July 1977

Photos 66 and 67 show the completed slope with the brush layering (willow sp.). A typical construction plan for the brush layering and fiberglass roving is shown in Figure 31.

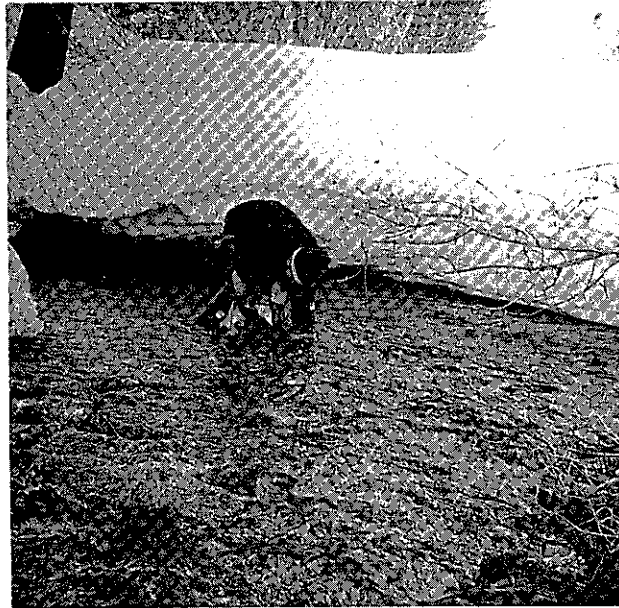
Photo 72  
Biologist Collecting Aquatic Macroin-  
vertebrate from Rock Creek (Site 3)  
March 1978

Station 1 lies approximately 150-300 feet below U.S. 395 at 09-Iny-395 PM 127.73 on Rock Creek at its confluence with Pine Creek. Substrate consisted of cobbles 3-8 inches in diameter, water depth 6-10 inches and relatively swift flow. Samples showed a fairly good diversity with Ephemeroptera (mayfly), Plecoptera (stonefly), and Tricoptera (caddisfly) predominating. There were also large numbers of Simuliidae (black flies) which should be expected since the area supports a number of cattle.

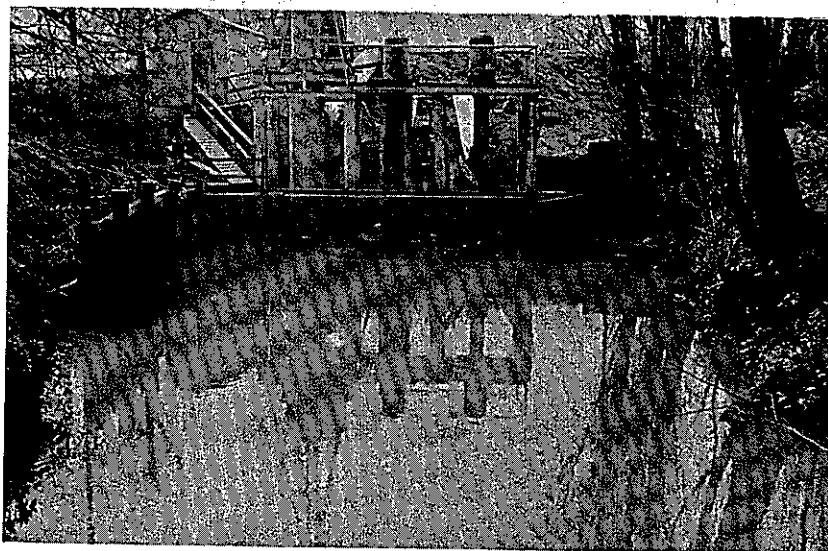
Photo 89

Pumps for Conveying Water into Lost Slough

Sampling locations 4 and 5 are drainage ditches that deliver irrigation and drainage water to sampling location 1, the ditch with pumps to convey the water into Lost Slough. Photos 86 and 87 show the constructed cross culverts at these locations. Photos 88 and 89 show the location of the main return ditch and pumps.

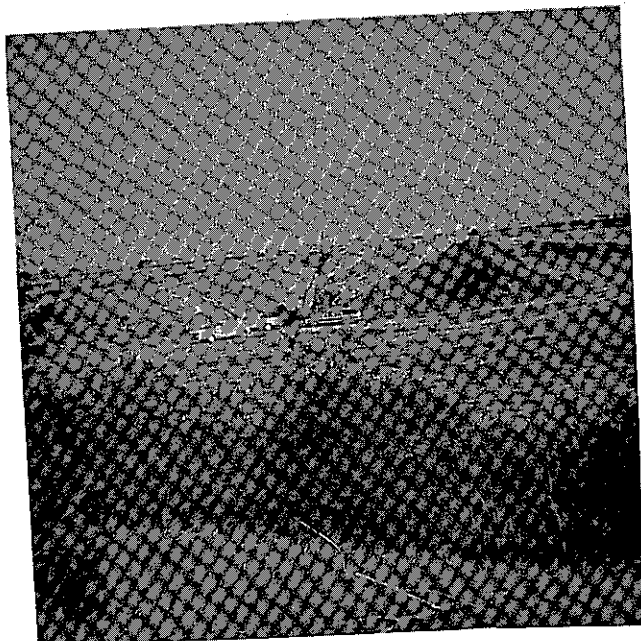
Photo 90  
Excavation of Material from Peripheral  
Canal in September 1977 (Looking North  
from Lost Slough Levee)

Embankment material for the I-5 project was obtained from three borrow sites along the centerline of the proposed Peripheral Canal (see Photos 90 and 91). The borrow sites were dewatered during excavation. The water was pumped to Lost Slough where it was discharged. Discharge was allowed as long as the river water level was at, or below, 7 feet above MSL. The specific conductivity of the river water was used to determine if there were any adverse effects from the discharge.

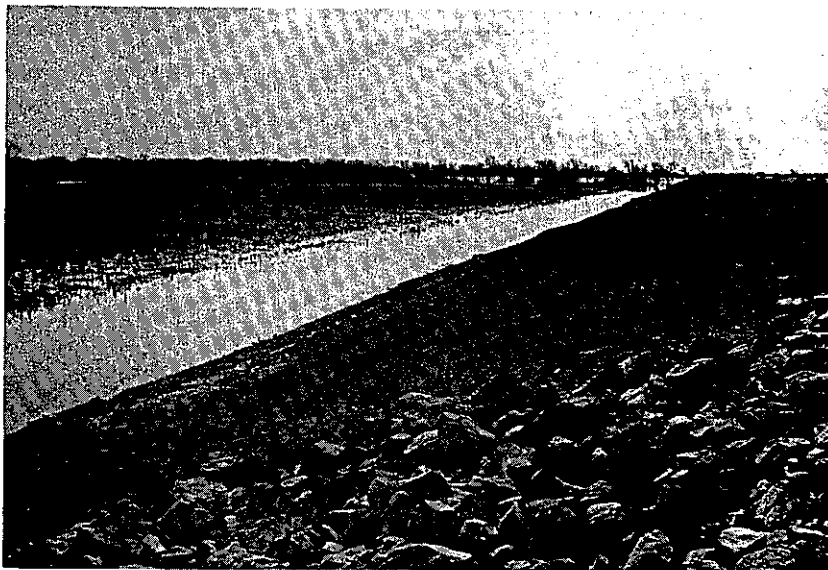
Photo 93  
The Fill Between Middle Slough and Lost  
Slough (Looking South from Lost Slough)  
Overflowing at Middle Slough, Water Flow-  
ing Along the Toe of Fill & into Lost  
Slough (March 2, 1979)

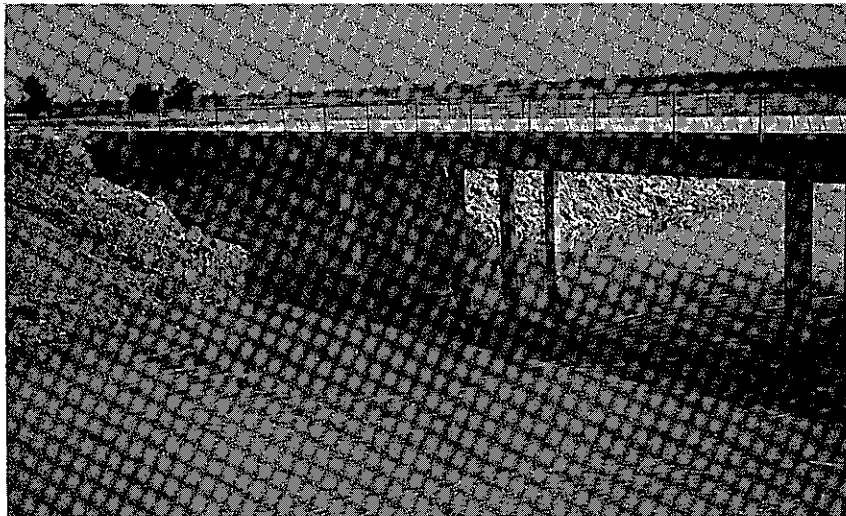
Photo 94  
Middle Slough-Northbound Bridge  
March 2, 1979

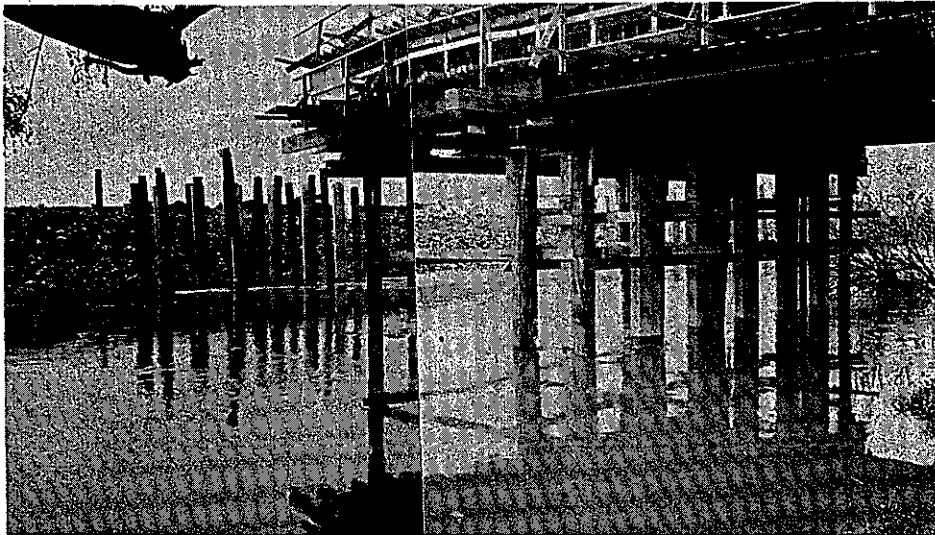
Photo 97

Mokelumne River Bridge-Northbound  
Partially Built (March 2, 1979)
